REPORT OF FLOOD TROPICAL STORM AGNES

JUNE 1972

OSWEGO RIVER BASIN

U.S.ARMY ENGINEER DISTRICT, BUFFALO

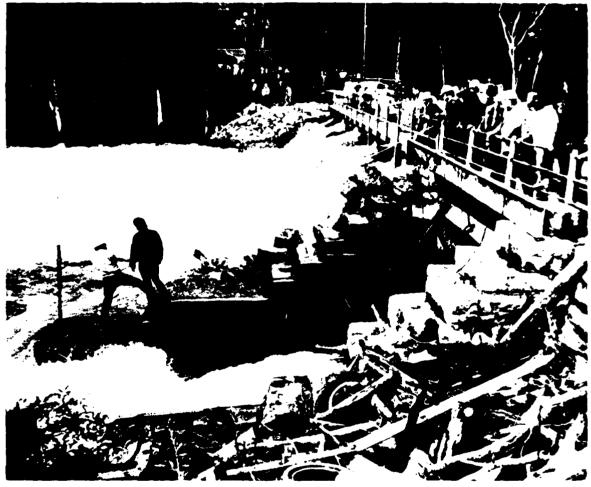
Figure 1 Workmen prepare to place large boulders in an attempt to reinforce a pier of the state dam at Owasco Lake outlet. Photo taken 25 June 1972.

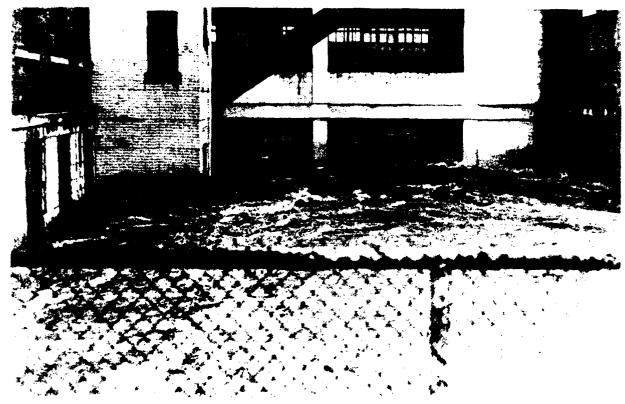
Figure 2 Owasco Lake outlet flood waters approximately ten feet above normal, at the Dunn and McCarthy Inc. plant. Water normally flows under the plant.

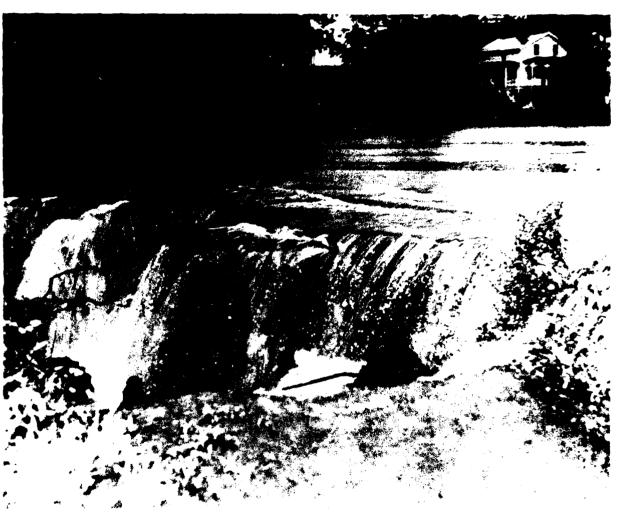
The Mill (Miller) St. dam, downstream of the State Dam, of stone masonry construction remained intact. However, the west abutment was washed out, throwing the force of the Owasco Outlet against the bluff causing severe erosion. Figure 13 shows the water overtopping the west abutment and Figure 14 shows the new stream bed cut through it.

Figure 13 $\,$ Flood waters top west abutment of Mill (Miller) Street Dam in Auburn on the Owasco Outlet.

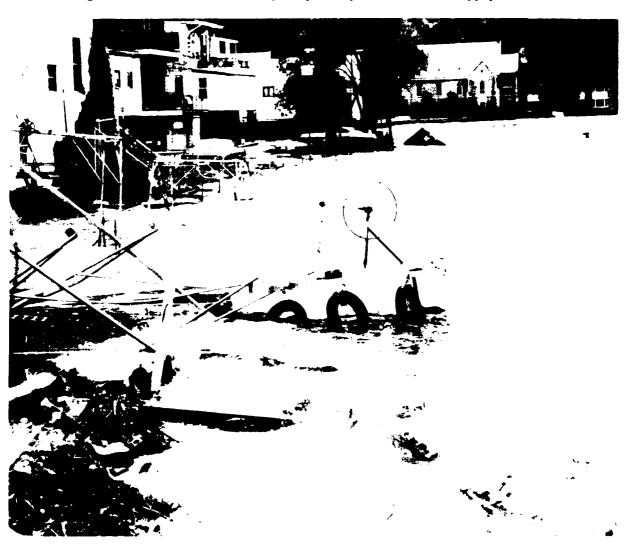
The June 1972 flood on Skaneateles Lake reached a record level, breaking the previous record of 1922 by approximately 0.7 foot. Regulation of the lake became a source of irritation during the June 1972 flood as it has during past floods. Some residents on the lake felt that larger releases from the lake should have been made to help alleviate flood conditions on the lake while residents along Skaneateles Creek were of the opinion that larger releases would not have significantly reduced levels on the lake and would actually make matters worse by flooding them, too. The control structure was operated to convey by conduits as much water as possible to City of Syracuse reservoirs and to release as much water as possible down Skaneateles Creek without flooding the residents along it. Figure 15 shows flooding conditions on Skaneateles Lake.

Figure 15 Flooding along rear of Genesee St. businesses on Skaneateles Lake.
